Twinning Project IL/11

Implementation and Strengthening the Environmental Framework for  
IPPC, Resource Efficiency and Eco-Management in Israel

# Release of HF in 2003

## Release of HF on July, 07th of 2003

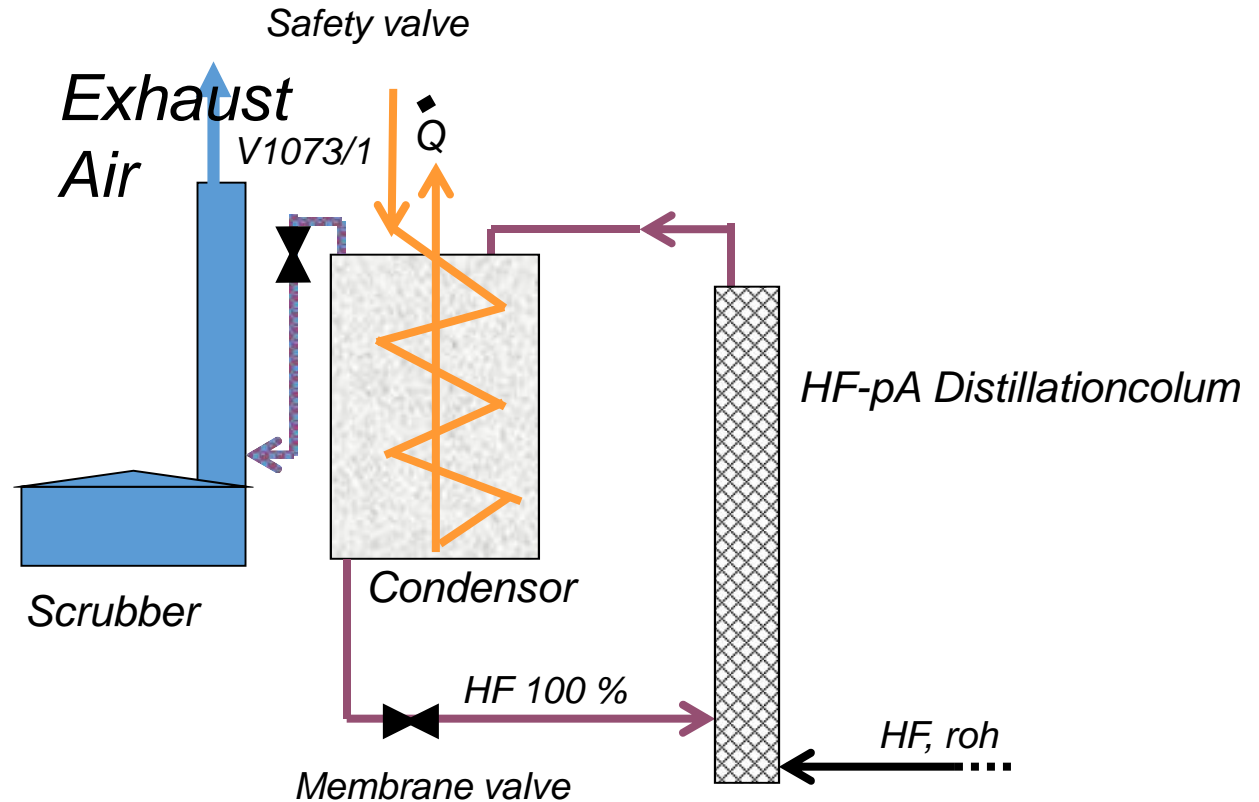
# Simplified Scheme of the Installation

In 2003 a container in the scrubber system burst and 12 kg of HF-Gas are released into the building and over the rooftop

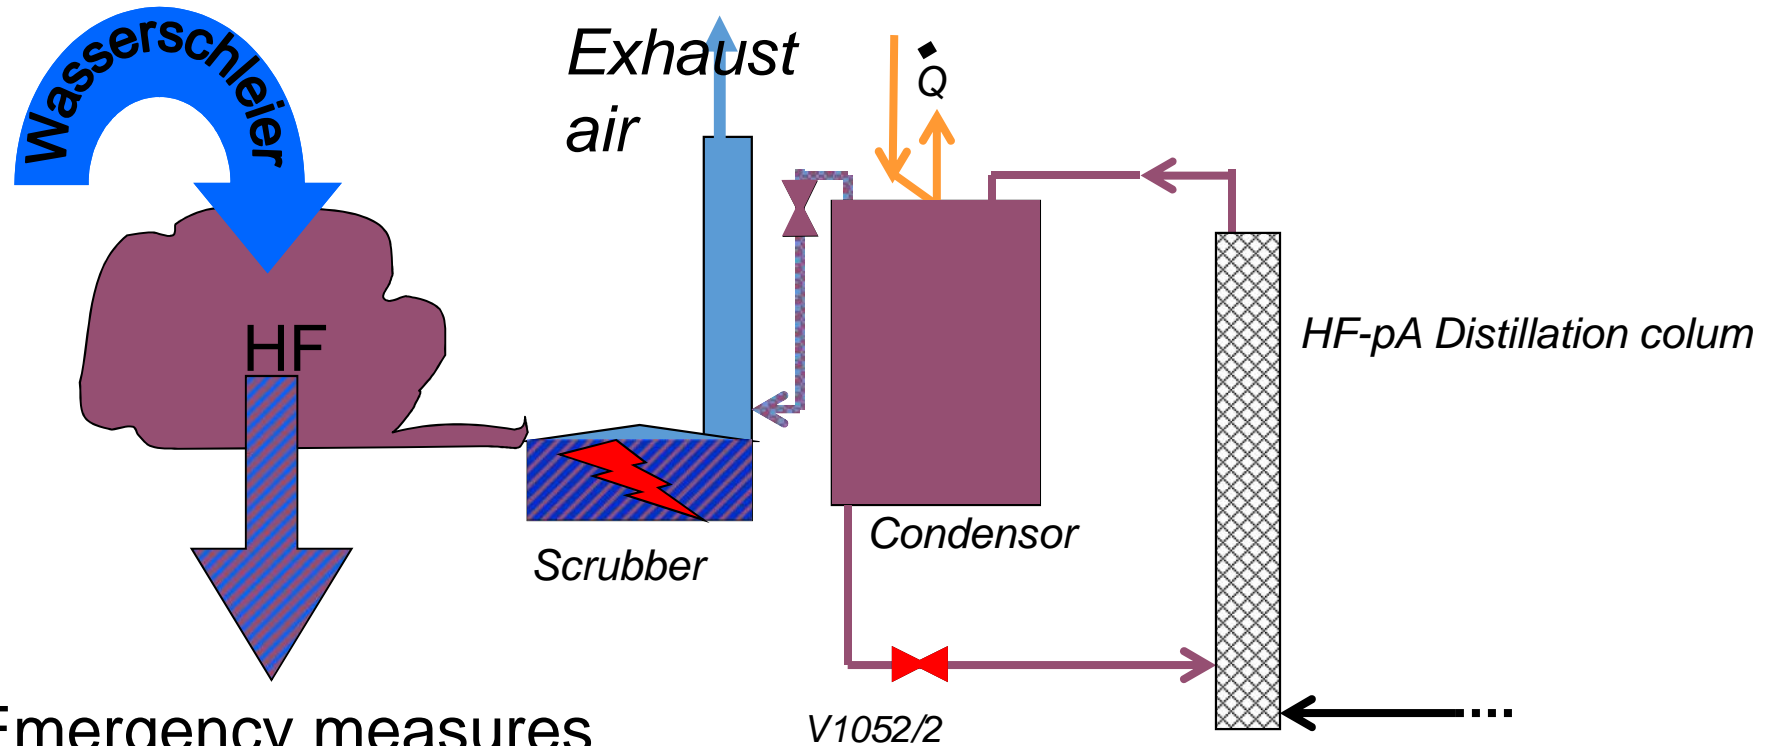
# The Scenario

Emergency measures  
by the fire brigade of  
the installation

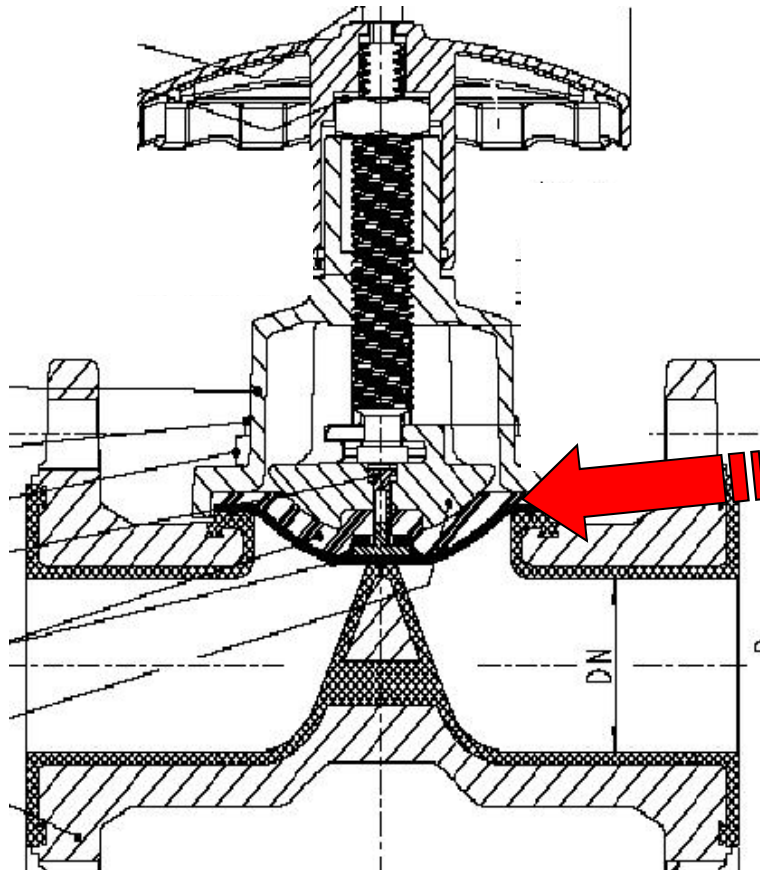
# Membrane valve

- The closed valve
- The protection layer of the membrane became leaky
- The highly concentrated HF lead to a swelling of the membrane
- The valve seems to be opened but in real the flow was reduced

- The trigger: defect membrane valve
- Lack of level meters in the gas system,  
(„no liquids in the gas system“)
- Enthalpie of mixing (Exothermie) when mixing HF  
with water or HF of different concentration

- Exchange of all membrane valves at least every two years if HF > 60 %
- Installation of level meters (overflow safety)
  - In the gas pipings
  - In the condensers
  - In case of alarm shut down of the distillation
- Update of the PID
- Elaboration of isometric piping diagrams
